Historic Resources Evaluation Avenue Water Treatment Plant, Ventura, California

14 May 2002

URS Corporation
130 Robin Hill Road
Santa Barbara CA 93117

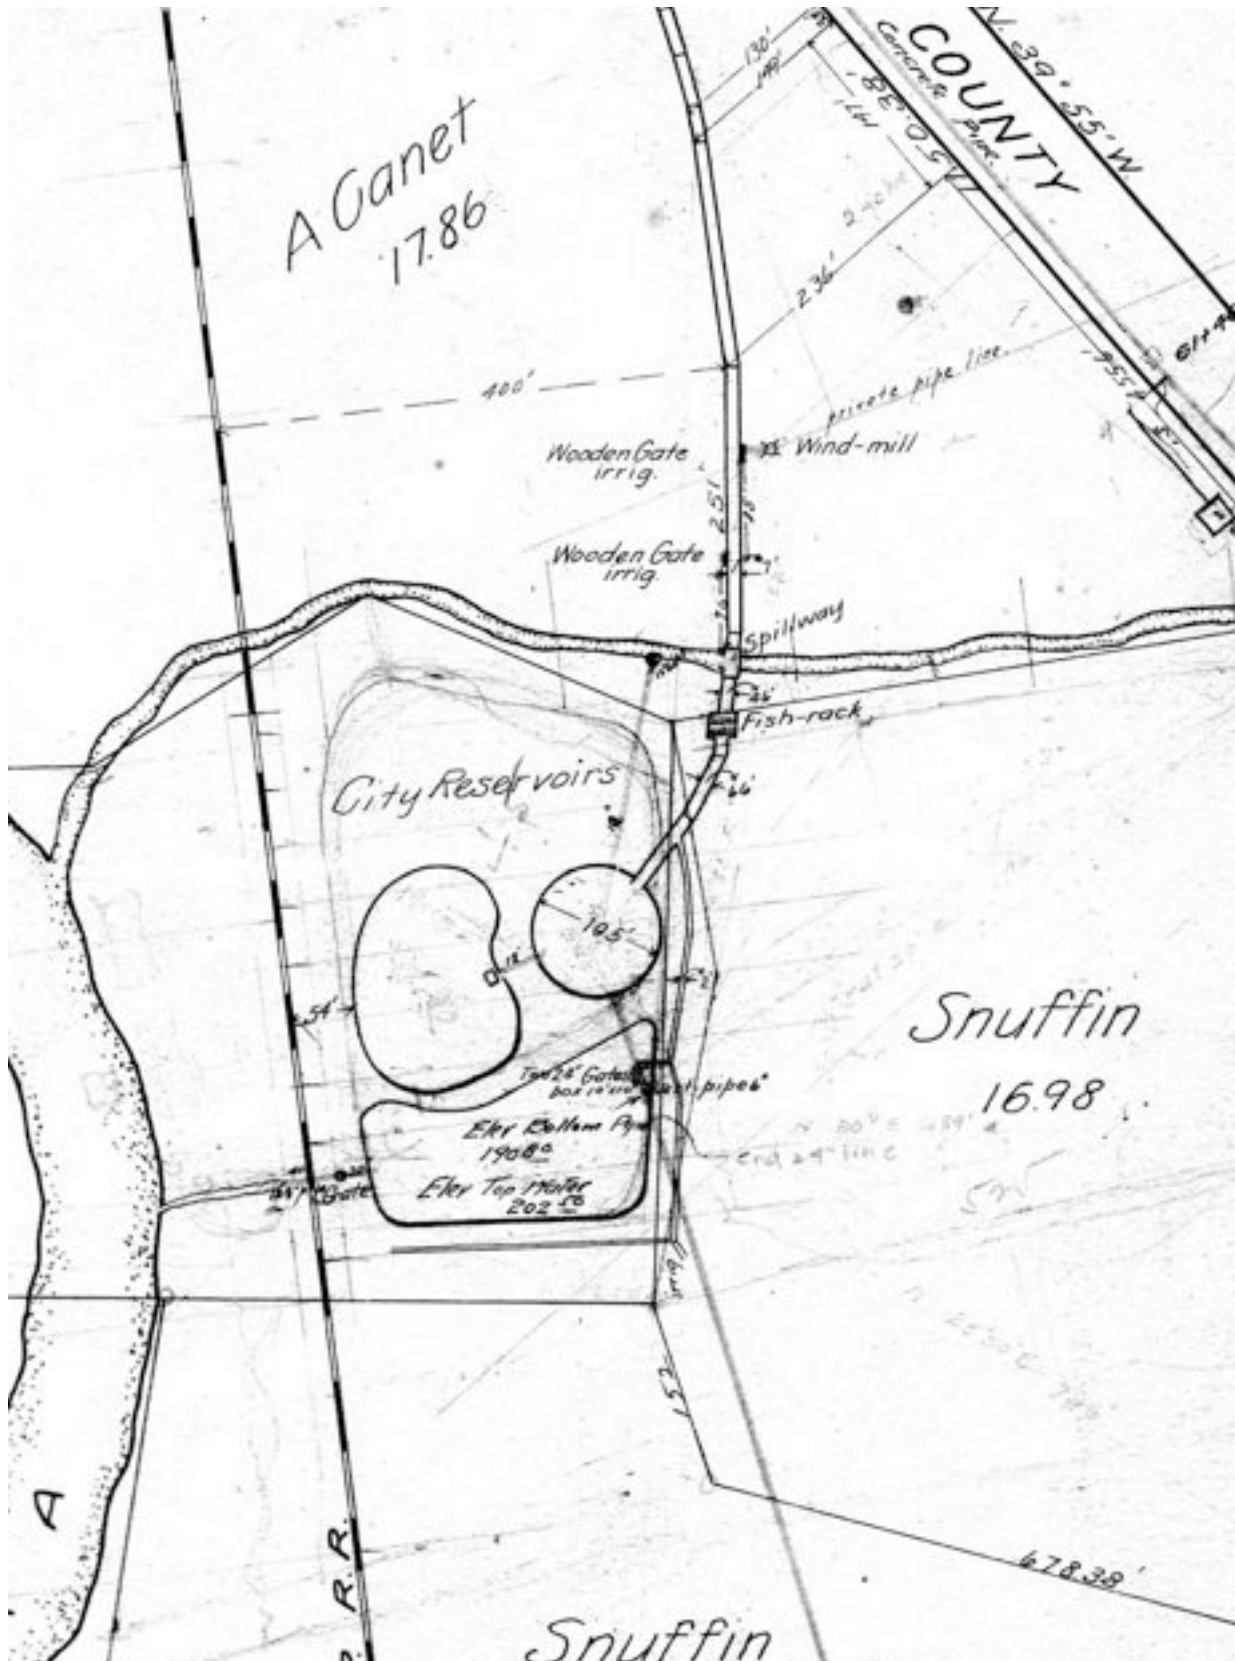
FIGURE 2. Ventura County Power Co. Facilities at Cañada Larga
 Source: Book of Ventura Avenue Showing Location of Ditches, Flumes, Pipe-lines, Reservoirs and other Property of the Ventura County Power Company, March 1910 (with later pencil notations).

By 1910, three small "city reservoirs" on the Cañada Larga site occupied the location of the present Kingston Reservoir. After 1929, these three reservoirs would be combined into the one large reservoir extant today. The Pacific Light and Power Corporation, a regional company operated by Pacific Electric Railway magnate Henry Huntington, acquired a controlling interest in the Ventura County Power Company in 1914. (Ventura County Power Company, 1910) [Figure 2]

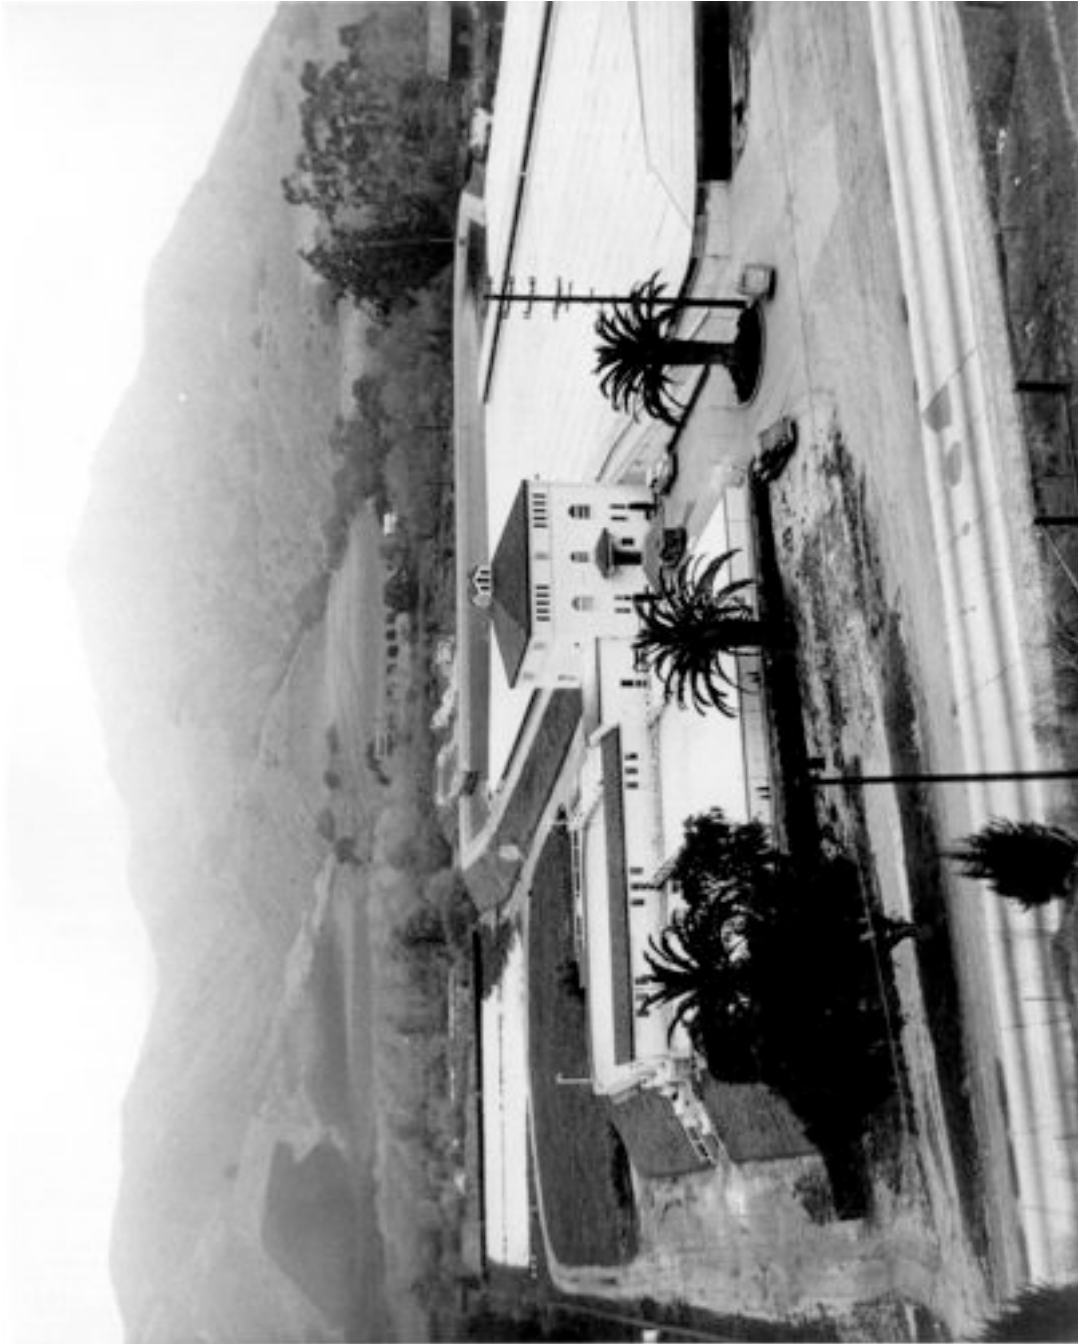
PHOTO 1. Overview of Avenue Water Treatment Plant, facing west, circa 1940 (Ventura County Museum of History and Art).

Three other segments of the water treatment program built in 1939 included the construction of a raw water pipe line from the Kingston reservoir to the city limits for irrigation purposes; the roofing over the Power Reservoir to protect the treated water from algae growth; and the concrete lining of the Weldon Channel north of the reservoirs to prevent bank erosion. Changes to the water treatment process undertaken by the city during the 1950s and 1970s resulted in minor alterations to the facility. [Photo 1]

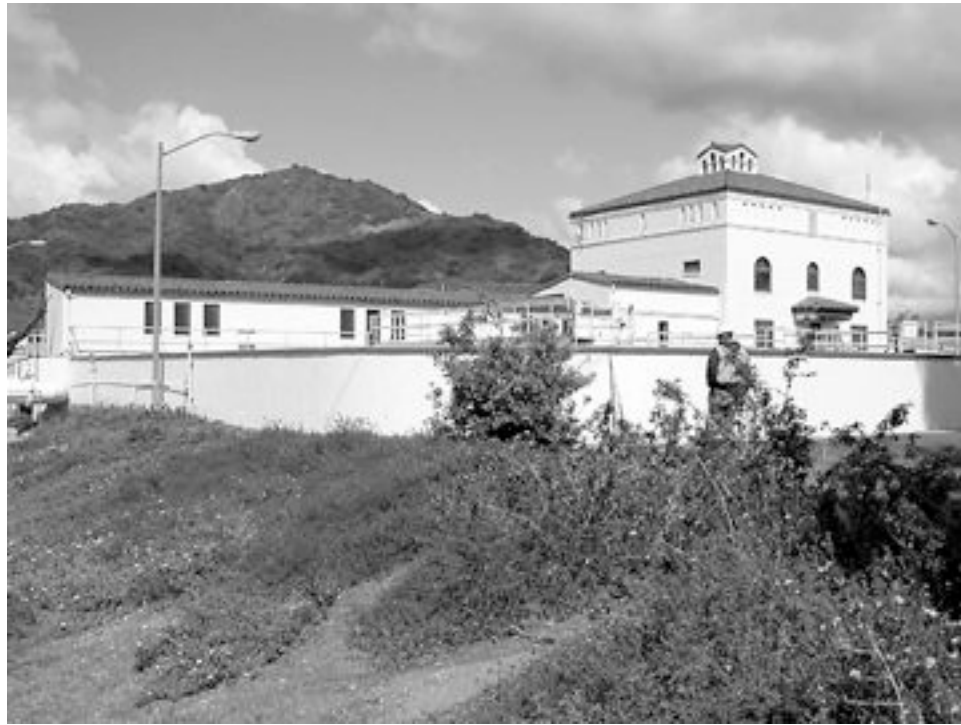
[1] Administration Building. The administration building is square in plan (40 by 40 feet), three stories in height plus a basement with a one story (97 by 12 foot) wing attached on the west side and is constructed of reinforced concrete with a grout lock brick exterior, painted white. The low steel-framed hipped roof of Spanish clay tile roof is capped with a four-sided cupola that repeats the rounded arches found in the windows of the second floors. Louvered wood vents are located within the arches. The Spanish Colonial Revival style building is symmetrical in design with a centered entry flanked by wood frame windows. A hipped roof covers the recessed entry supported by wrought iron brackets. The second floor features three round radiating arched multipaned double hung wood windows evenly spaced across the front (east) elevation. The third floor (east elevation) is divided from the second by a stringcourse and features a grouping of five narrow rectangular openings on each side with a single decorative vent in the middle. All of these openings serve as vents. The narrow vents have been covered with plywood. Decorative brick is used to create a cornice line. [Photo 2]

The one-story long rectangular-plan wing features a low gable roof covered with Spanish clay tiles with exposed rafters under the shallow eaves. The rectangular wood windows are organized in three groups of three windows each across the front (east) elevation. The windows run across the entire west elevation, interrupted by a four-paned glass and wood door in the middle. Most all of the wood windows on the west side have been replaced with aluminum windows within the original openings. Three wood and glass doors are located on the west side. The upper half of the west side of the building is covered with wide horizontal wood siding and corbeled wood pilasters. The lower half is constructed of brick.

PHOTO 2. Front (eastern) elevation, Administration Building, facing northwest (30 April 2002).

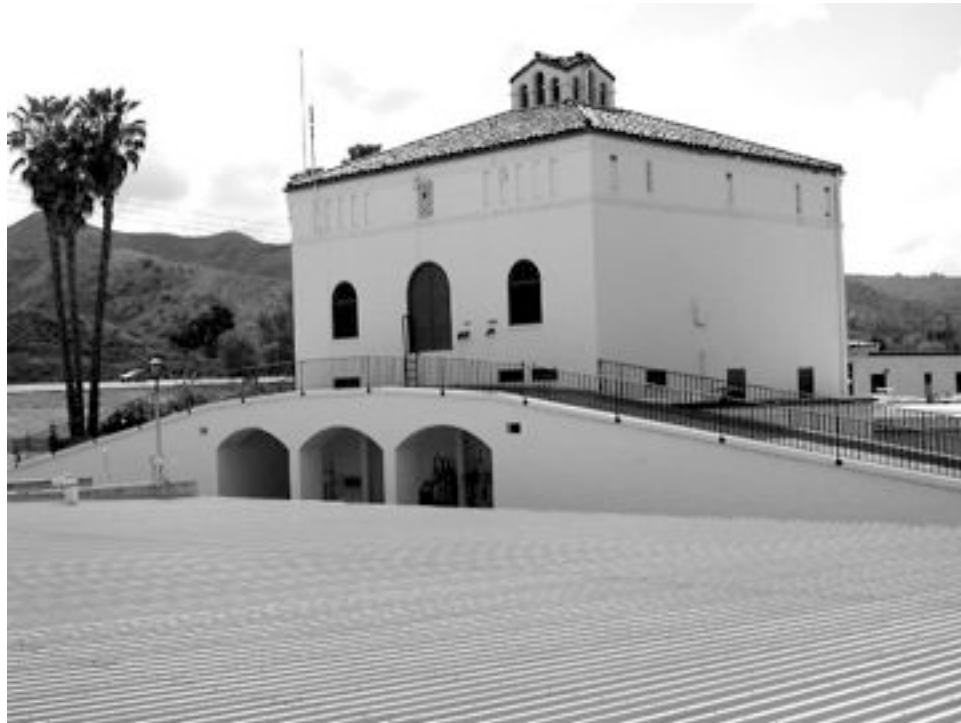
On the north side of the building is a concrete loading ramp extending up to the second floor, with a large round arched paneled recessed entrance door flanked by two round arched multi-paned wood windows. Above the entrance is a decorative brick vent with five narrow openings on either side, repeating the design on the front of the building. Underneath the ramp are three segmented arched openings with radiating brick. A wrought iron railing extends the length of both sides of the ramp. [Photo 3]

PHOTO 3. Northern and western elevation, Administration Building, Power Reservoir in foreground, facing southeast (30 April 2002).

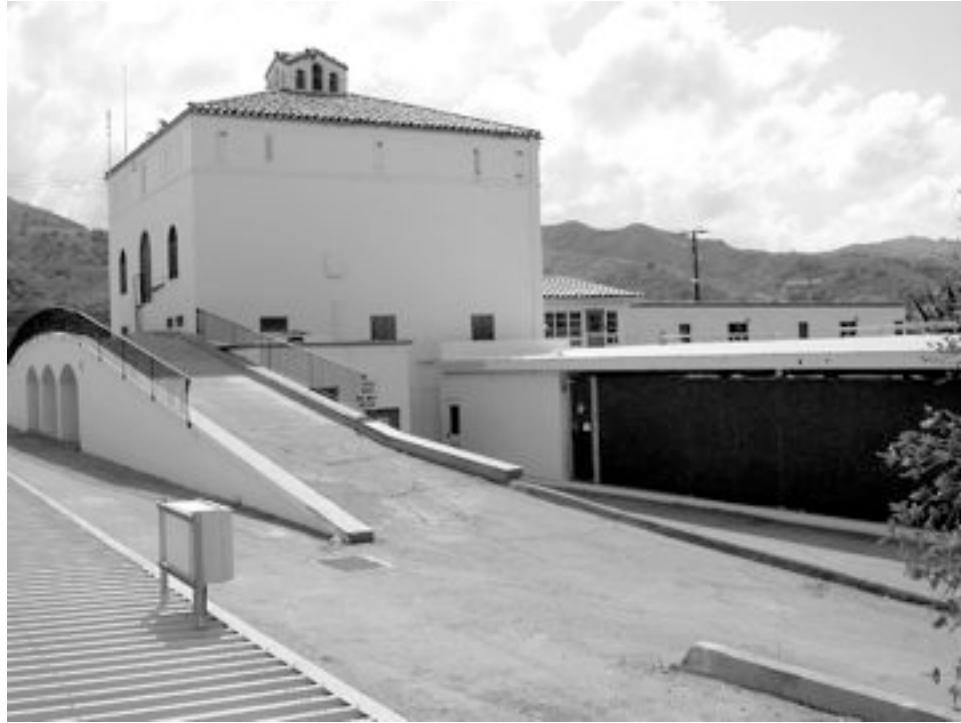
The west (rear) elevation consists of two, flat roofed concrete block wings, probably added between 1958 and 1973. The small northern addition (electrical equipment room) features metal-framed windows. The southern addition is long and narrow and open on the north side for chlorine tank storage enclosed behind a metal fence. Above the additions are three evenly spaced rectangular wood windows. Five narrow vent openings are repeated under the roofline. Two contain their original louvered vents, and three are covered with plywood. [Photo 4]

PHOTO 4. Rear (western) elevation, Administration Building, facing east (30 April 2002).

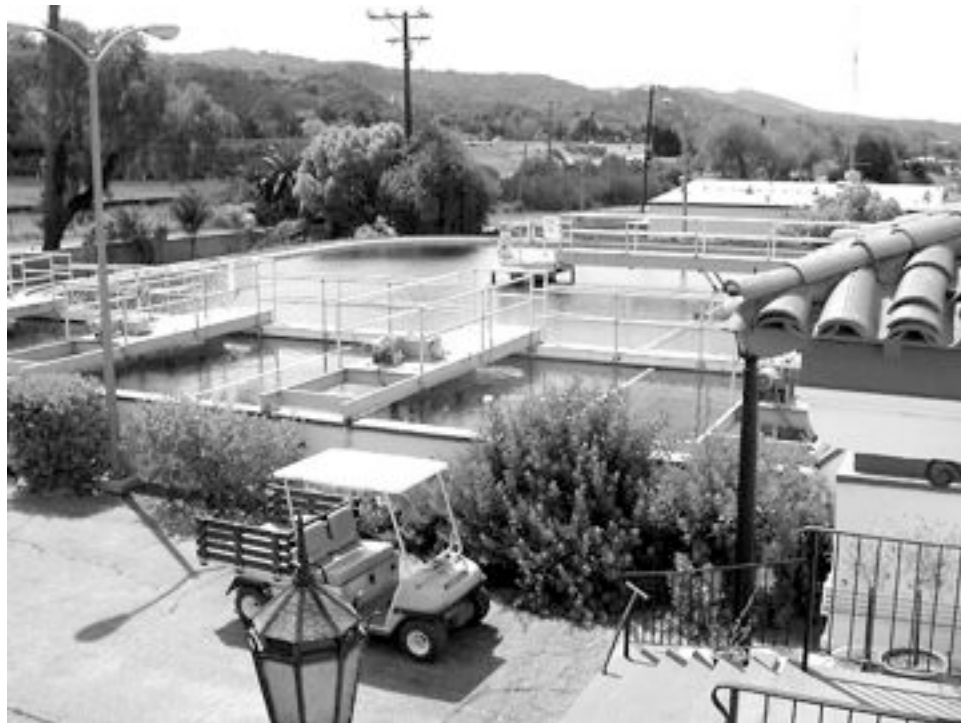
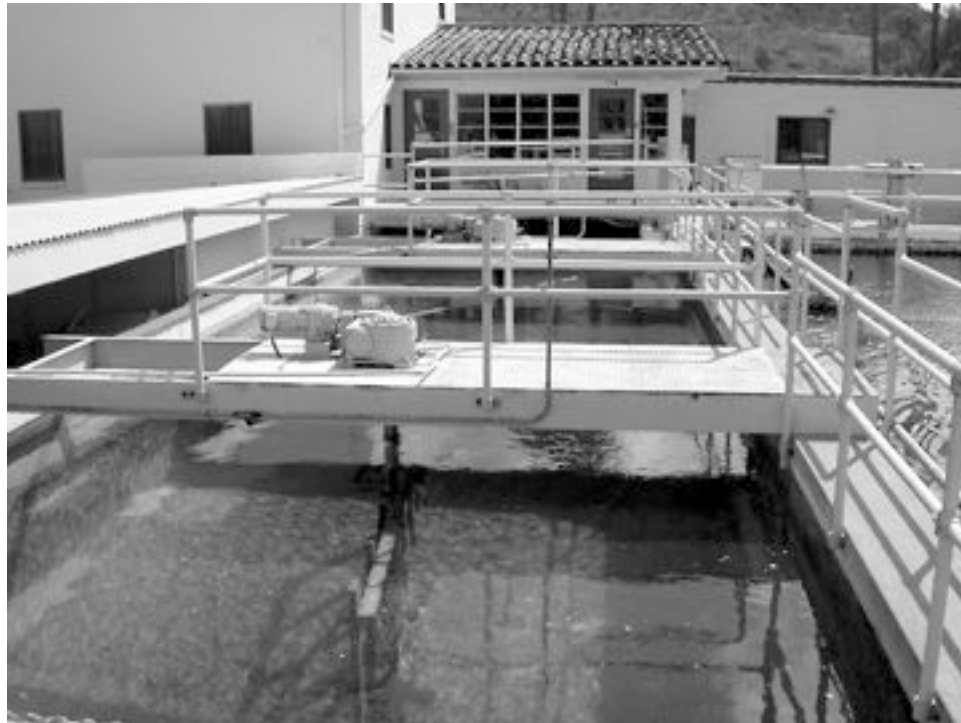
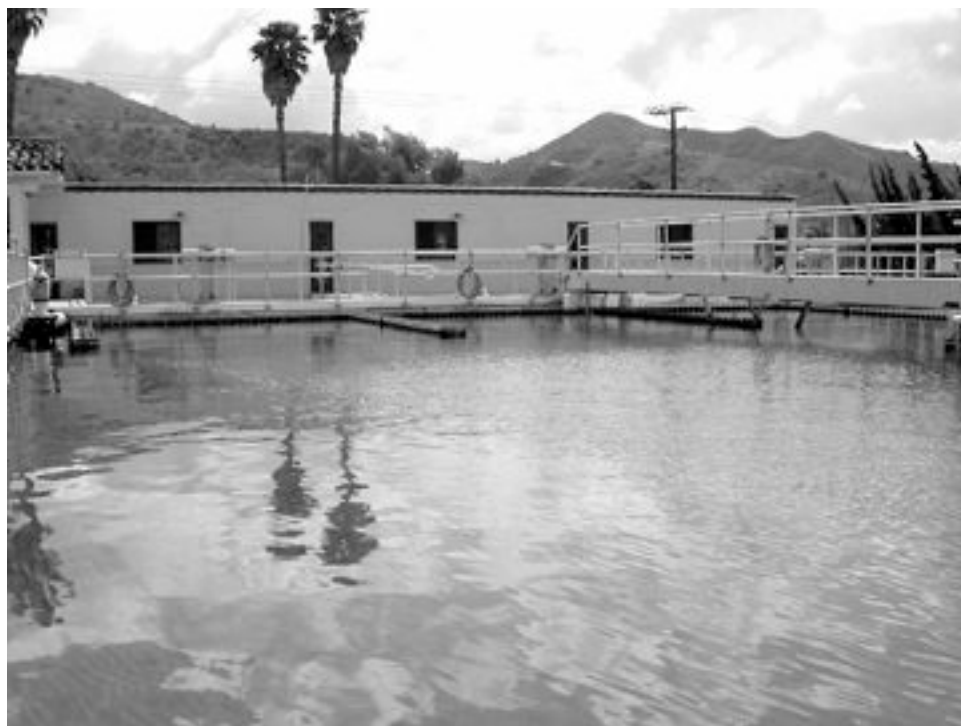
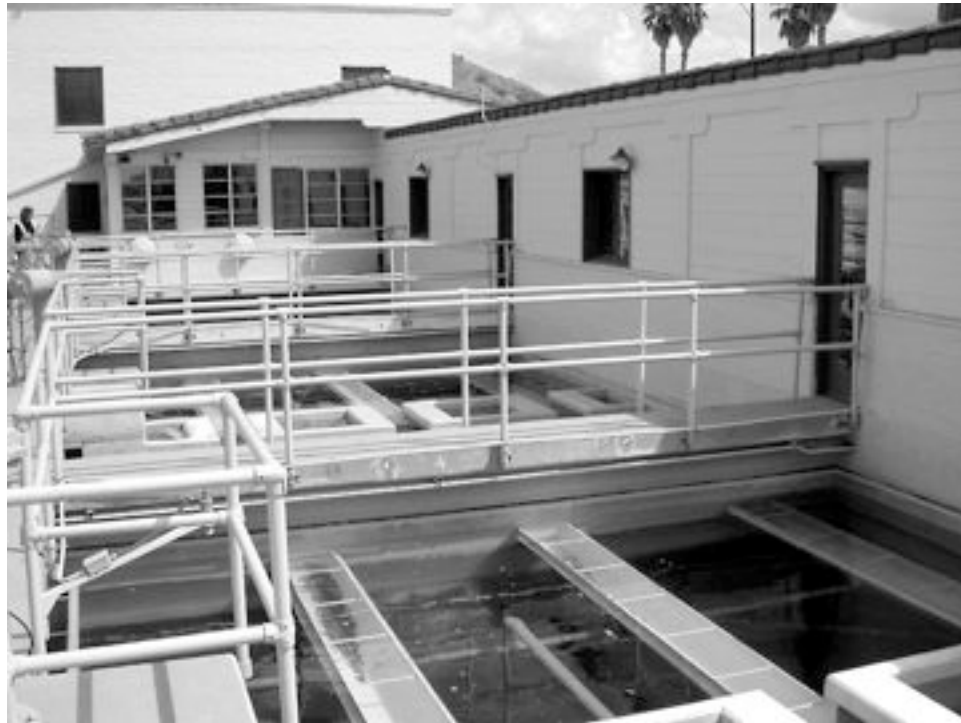
[2] Treatment and Settling Basins. On the north and south sides of the administration building are large reinforced concrete basins for treating raw water from the reservoirs. These basins are surrounded by brick walls painted white and capped with red brick. Metal catwalks with pipe railings extend over the basins. The water treatment process consists of several steps. The first step is the coagulation and flocculation basin. The second step is the sedimentation process where the water stands in quiet pools for settling out

of sediments. The third step is the clarification process where the water is passed through filter beds. Following the filtration, the final step is the disinfection process.

The primary flocculator basin measures roughly 22 by 81 feet, and 12 feet deep. The secondary flocculator basin measures approximately 18 by 98 feet and 12 feet deep. The primary clarifier measures 75 by 75 feet and 14.5 feet deep. The secondary clarifier measures approximately 75 by 75 feet, and 14.5 feet in depth. The three filter basins measure roughly 79 by 24 feet and 11 feet in depth. During revisions to the plant in 1973, the circular sludge collector was replaced in the rear basin. [Photos 5, 6, 7, 8]

PHOTO 5. Primary Flocculator/East Sedimentation Basin, facing south (30 April 2002).

PHOTO 6. Secondary/West Flocculator, facing east (30 April 2002).

PHOTO 7. West Sedimentation Basin, facing east (30 April 2002).

PHOTO 8. Filter Beds, facing north (30 April 2002).

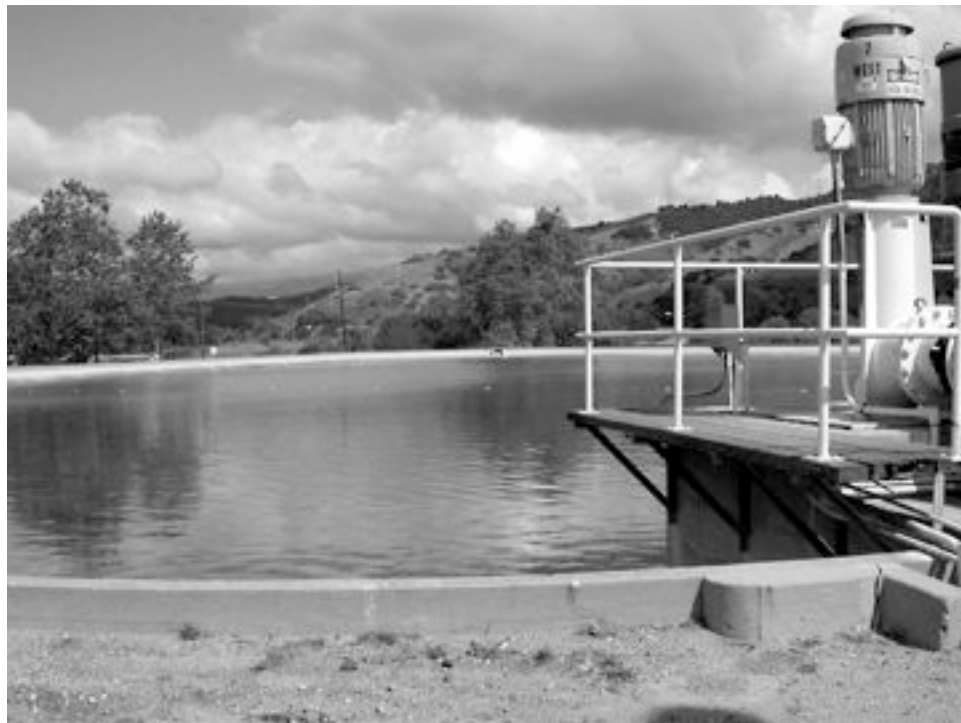
[3] Kingston Reservoir. This reservoir site consisted of three small earthen reservoirs when the city acquired the water system in 1923. In 1929 the two northern reservoirs were joined into one reservoir, leaving a dike between the resulting northern and southern reservoirs. Plans were made in 1931 to combine the reservoirs and to reline and reconstruct them in concrete, but apparently these plans were not carried out until 1939. The present reservoir is an irregular shaped structure, approximately 420 feet long by 285 feet wide at the top, sloping sides, 18.5 feet deep, set in a cut and rolled fill embankment with a ten foot berm around the edge. The walls and base are of six inch reinforced concrete with weep holes. The storage capacity is eleven million gallons. The reservoir includes an inlet, outlet, valves and piping. A concrete outlet box located in the reservoir delivers raw water for irrigation purposes. Two pumps are also housed in the outlet box which deliver the influent to the treatment plant. The reservoir was named after W.R. Kingston, a previous owner of the land. [Photo 9]

PHOTO 9. Kingston Reservoir, facing north (30 April 2002).

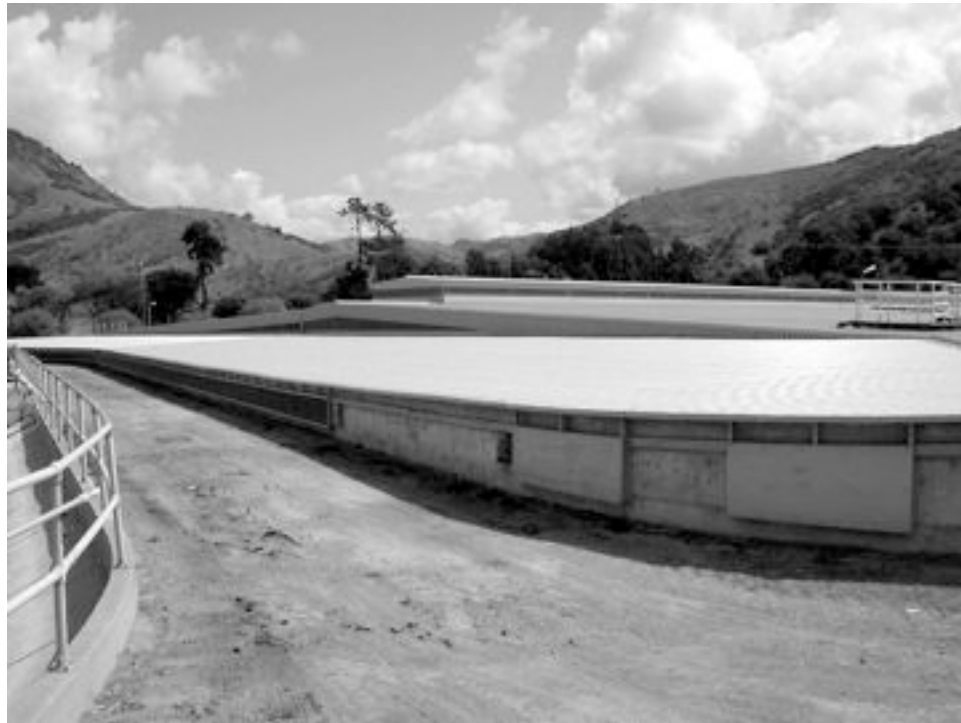
The present Power Reservoir was built in 1939. It is a concrete lined, covered reservoir measuring 500 by 336 feet, with a maximum depth from the floor to column tops of 29 feet. The roof support system consists of 491 precast concrete, 14 by 14 inch columns, each weighing up to 5,100 pounds; and 93, 12 by 12 inch columns on the slopes (Nutter, 1939: 415).

The roof is low-pitched, with hipped and gabled ends, with a gabled monitor ridge ventilator running the length of the roof from east to west and covered with corrugated metal. An 18 foot high screen was constructed around the base at the curb of the reservoir. The corrugated metal roof material was replaced with a ribbed steel roof in 1994. At the same time, new stainless steel strengthening plates were added to the columns internally. [Photo 10]

PHOTO 10. Power Reservoir, facing north (30 April 2002).

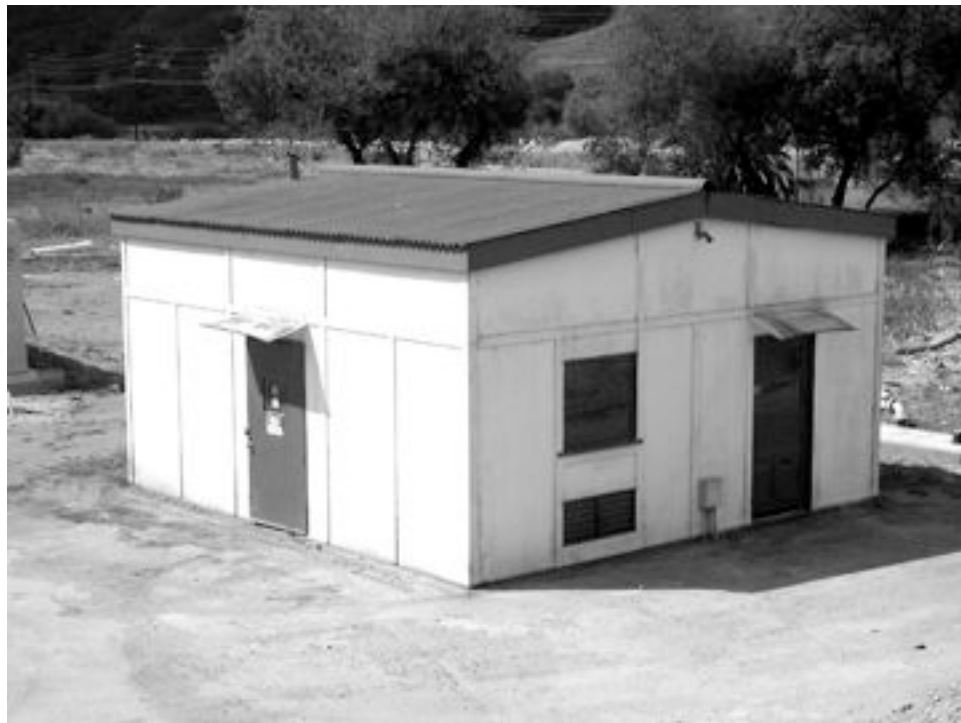
[5] Chlorination and Booster Pumping Station (Valley Vista Building). This square plan building has a very low gable roof. The building is covered with masonite panels and has a wood and glass door and a double hung woodframe window. It was built circa 1952. [Photo 11]

PHOTO 11. Chlorination and Booster Pumping Station/Valley Vista Building, facing southwest (30 April 2002).

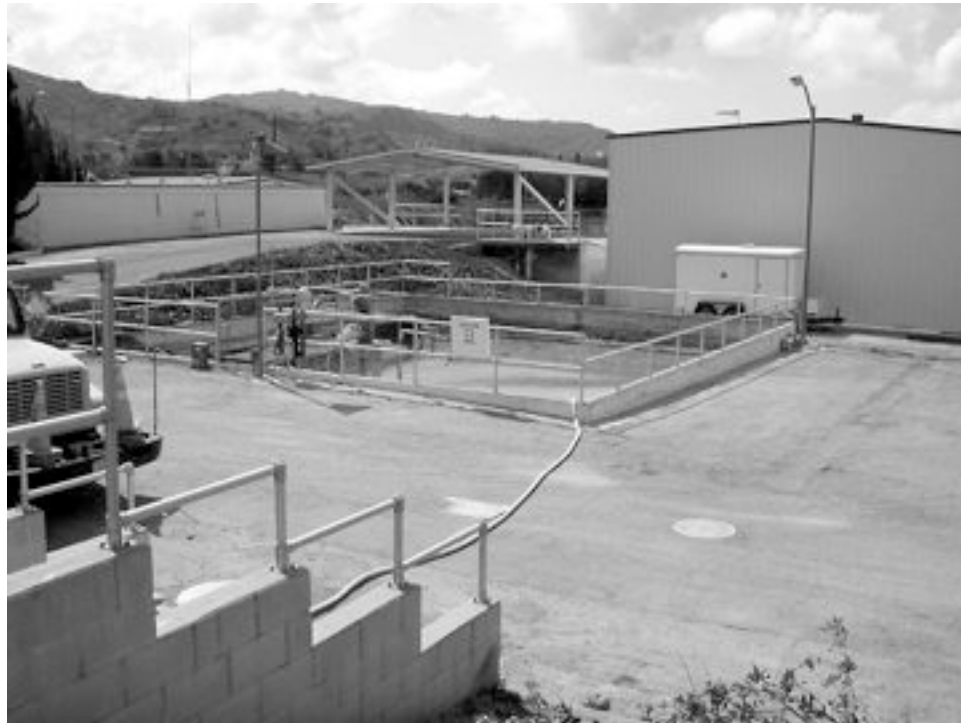
[7] Washwater Basin No 1. Located behind the treatment plant and south of the Power Reservoir is this basin with raised concrete sides and a metal pipe railing. This basin was built in 1939 and measures 40 by 46 feet and 7 feet deep. [Photo 12]

[9] Shop and Storage Building. This ribbed steel metal building with a low-pitched gable roof, 50 by 55 feet in plan, was constructed in 1973 over the former Sea Water Basin. [Photo 12]

[11] Sludge Dewatering Unit. This open-sided building constructed in 1973 has a metal gable roof over a concrete slab foundation supported by steel posts. [Photo 12]

PHOTO 12. Wash Water Basin No. 1, Shops and Storage Building, Sludge Dewatering Unit at rear, facing south (30 April 2002).

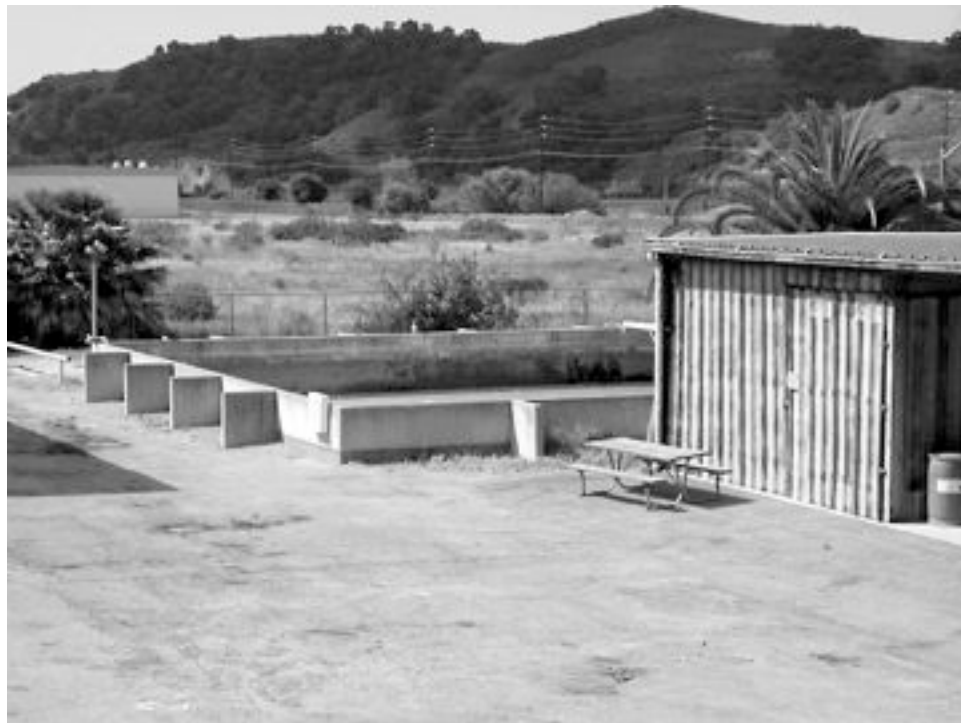
[8] Washwater Basin No. 2. This concrete 54 by 54 foot basin was constructed circa 1952 as a waste brine basin. It is 5.5 feet deep. [Photo 13]

[10] Garage. This partially open-sided corrugated metal building, approximately 20 by 60 feet in plan, appears on this site by 1973, but based on visual evidence, was probably constructed elsewhere and moved to its current location. [Photo 13]

PHOTO 13. Wastewater Reclamation Basin No. 2, garage in foreground, facing southwest (30 April 2002).

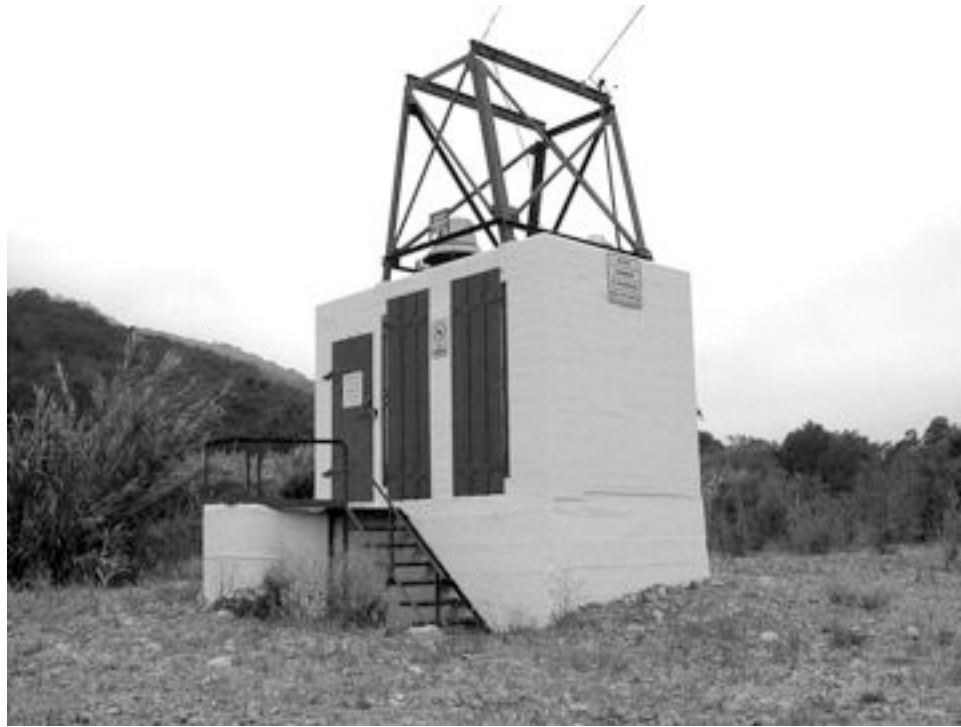
[13] Foster Park Intake Building. This rectangular plan building was built at some point between 1906 and 1911, along with and directly on top of the submerged dam. It is constructed of poured in place concrete and has a flat roof. The building rests on a high perimeter foundation with an attached stairway and railing leading up to the landing and entrance. Three steel doors are located on the southern elevation, along with a steel stairway. A steel electrical mast is located on the roof. Three galleries, including a 32.5 foot deep wet well located inside the building, serve as an impounding area for water transferred through the outflow pipeline to the treatment plant. Underground inflows have apparently been added and disconnected from the building during its service life. Some reconstruction of the facility occurred after the floods of 1969. [Photo 14]

PHOTO 14. Foster Park Intake Building, viewed from southeast. (30 April 2002).

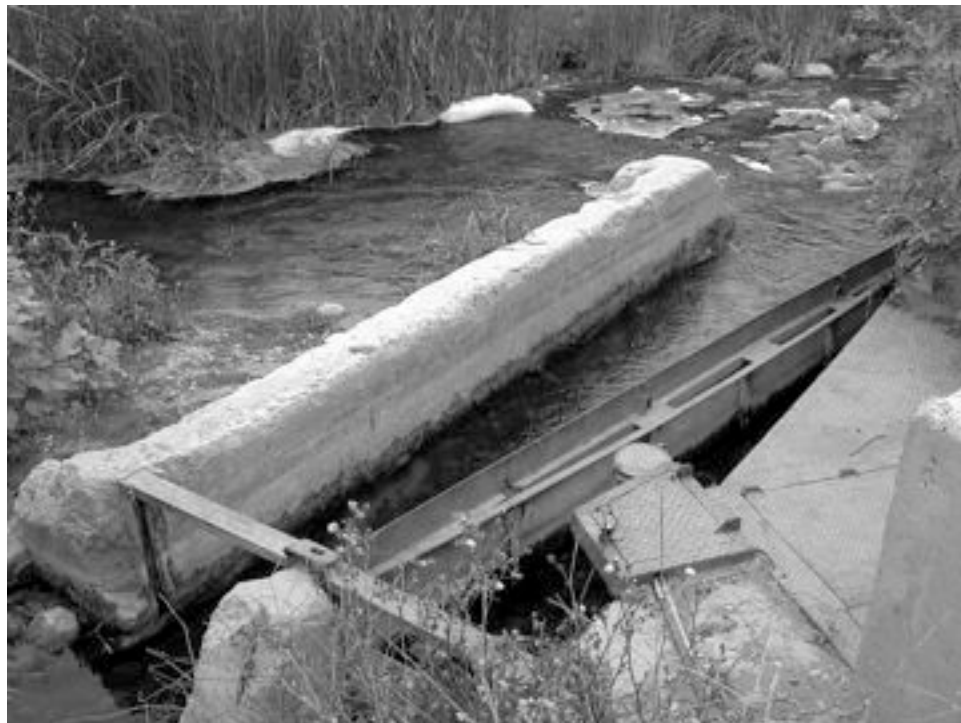
[14] Foster Park Surface Diversion. The surface diversion structure is located upstream from the submerged dam. The intake is an exposed concrete channel approximately three feet wide and ten feet long, containing steel sluice gates that replaced earlier wooden gates. The date of construction is uncertain, but it appears to have been in service at least as early as 1938. The diversion no longer supplies water to the intake building. [Photo 15]

PHOTO 15. Foster Park Surface Diversion, viewed from west. (30 April 2002).
